DELAWARE RIVER BASIN
NORTH BRANCH RANCOCAS CREEK,
BURLINGTON COUNTY
NEW JERSEY

MILL DAM
NJ 00540

PHASE 1 INSPECTION REPORT
NATIONAL DAM SAFETY PROGRAM

79 05 14 201
May, 1979

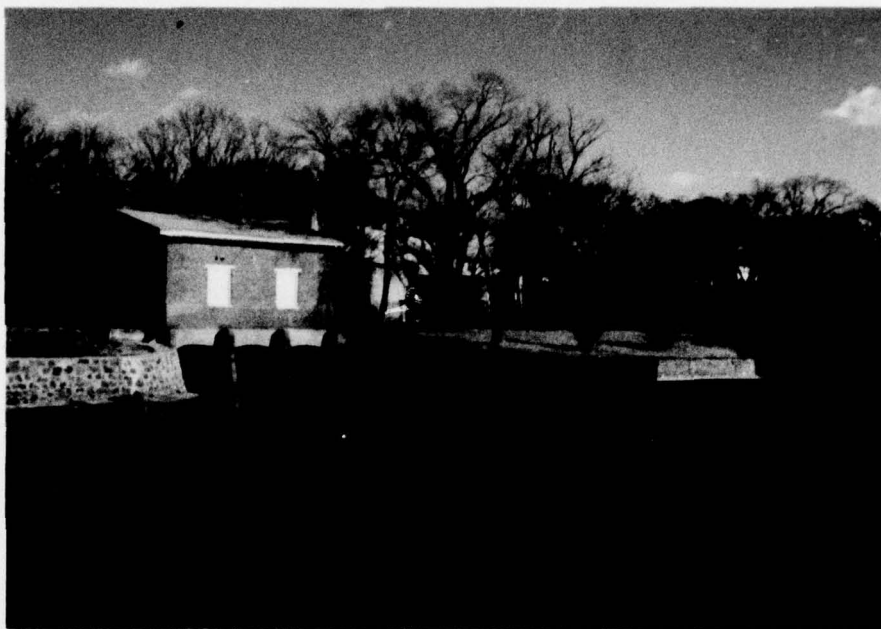
PHOTO 5

The spillway facilities at the abandoned power house were generally in poor condition, but appeared to be outwardly structurally sound. Concrete surfaces were typified by exposed aggregate. The timber slide gates were inoperable and closed at the time of inspection.

DOWNSTREAM VIEW OF ABANDONED POWER HOUSE.
DOWNSTREAM FACE OF EMBANKMENT.
